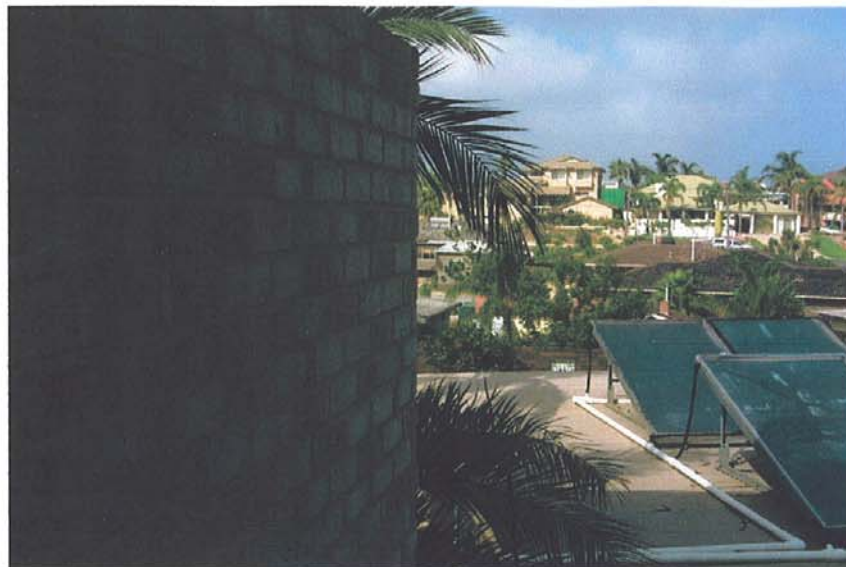
Figure 1: Patio (not pergola) has been constructed to Southern side of property. Adjoining property is set significantly lower.
