Camberwarra ~~Primary School Site~~ Local Structure Plan

'Track Changes' Draft for consideration by the City of Joondalup Council
December 2013

STRUCTURE PLAN N^o. ~~(TBC)~~16

This Structure Plan is prepared under the provisions of Part 9 of the City of Joondalup *District Planning Scheme No. 2*.

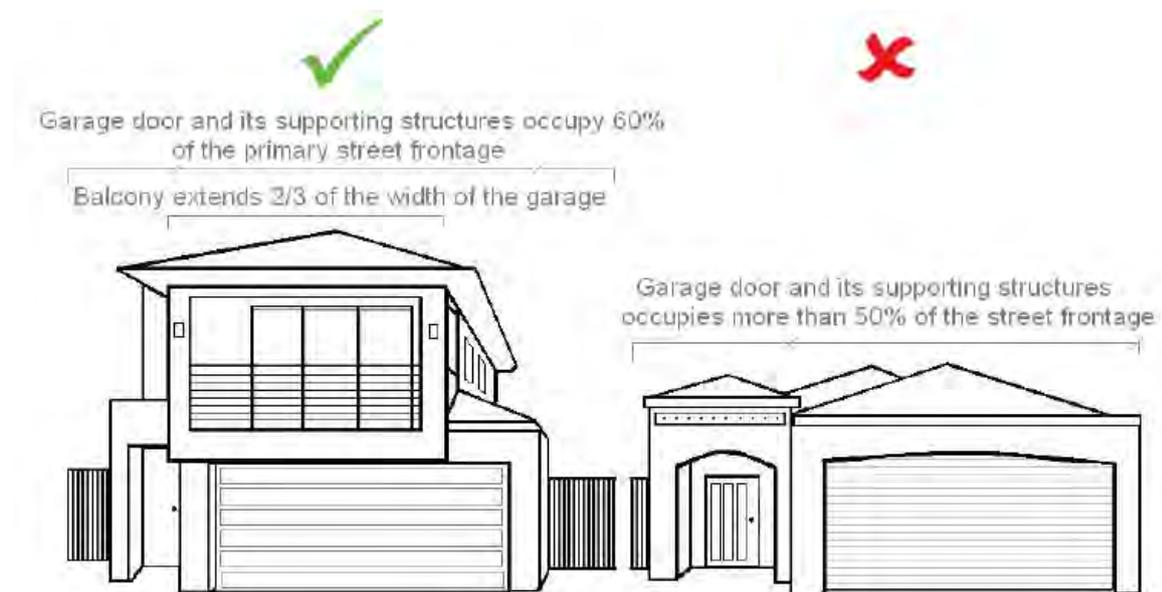
- d) [The 'deemed-to comply' requirement C2 of Clause 5.2.2 \(Garage Width\) of the Residential Design Codes is replaced with the following:](#) A garage door and its supporting structures shall not occupy more than 50% of the primary street frontage at the setback line [as viewed from the street](#). This may be varied to 60% where a balcony or upper floor with major openings extends 2/3 of the width of the garage (refer below figure).

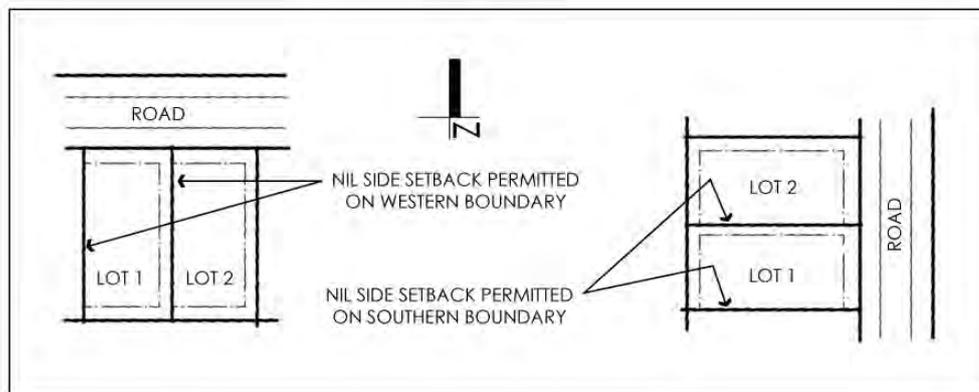
- a) i. Boundary walls to nominated side boundaries are permitted. For north/south oriented lots the nominated side boundary shall be the western boundary and for east/west oriented lots the nominated side boundary shall be the southern boundary (excluding to street and public open space boundaries).
- b) ii. Boundary walls shall be to a maximum height of 3.2 metres from natural ground level, for a total length of 9 metres, and be setback a minimum of 1.5 metres behind the dwelling frontage (face of the building).

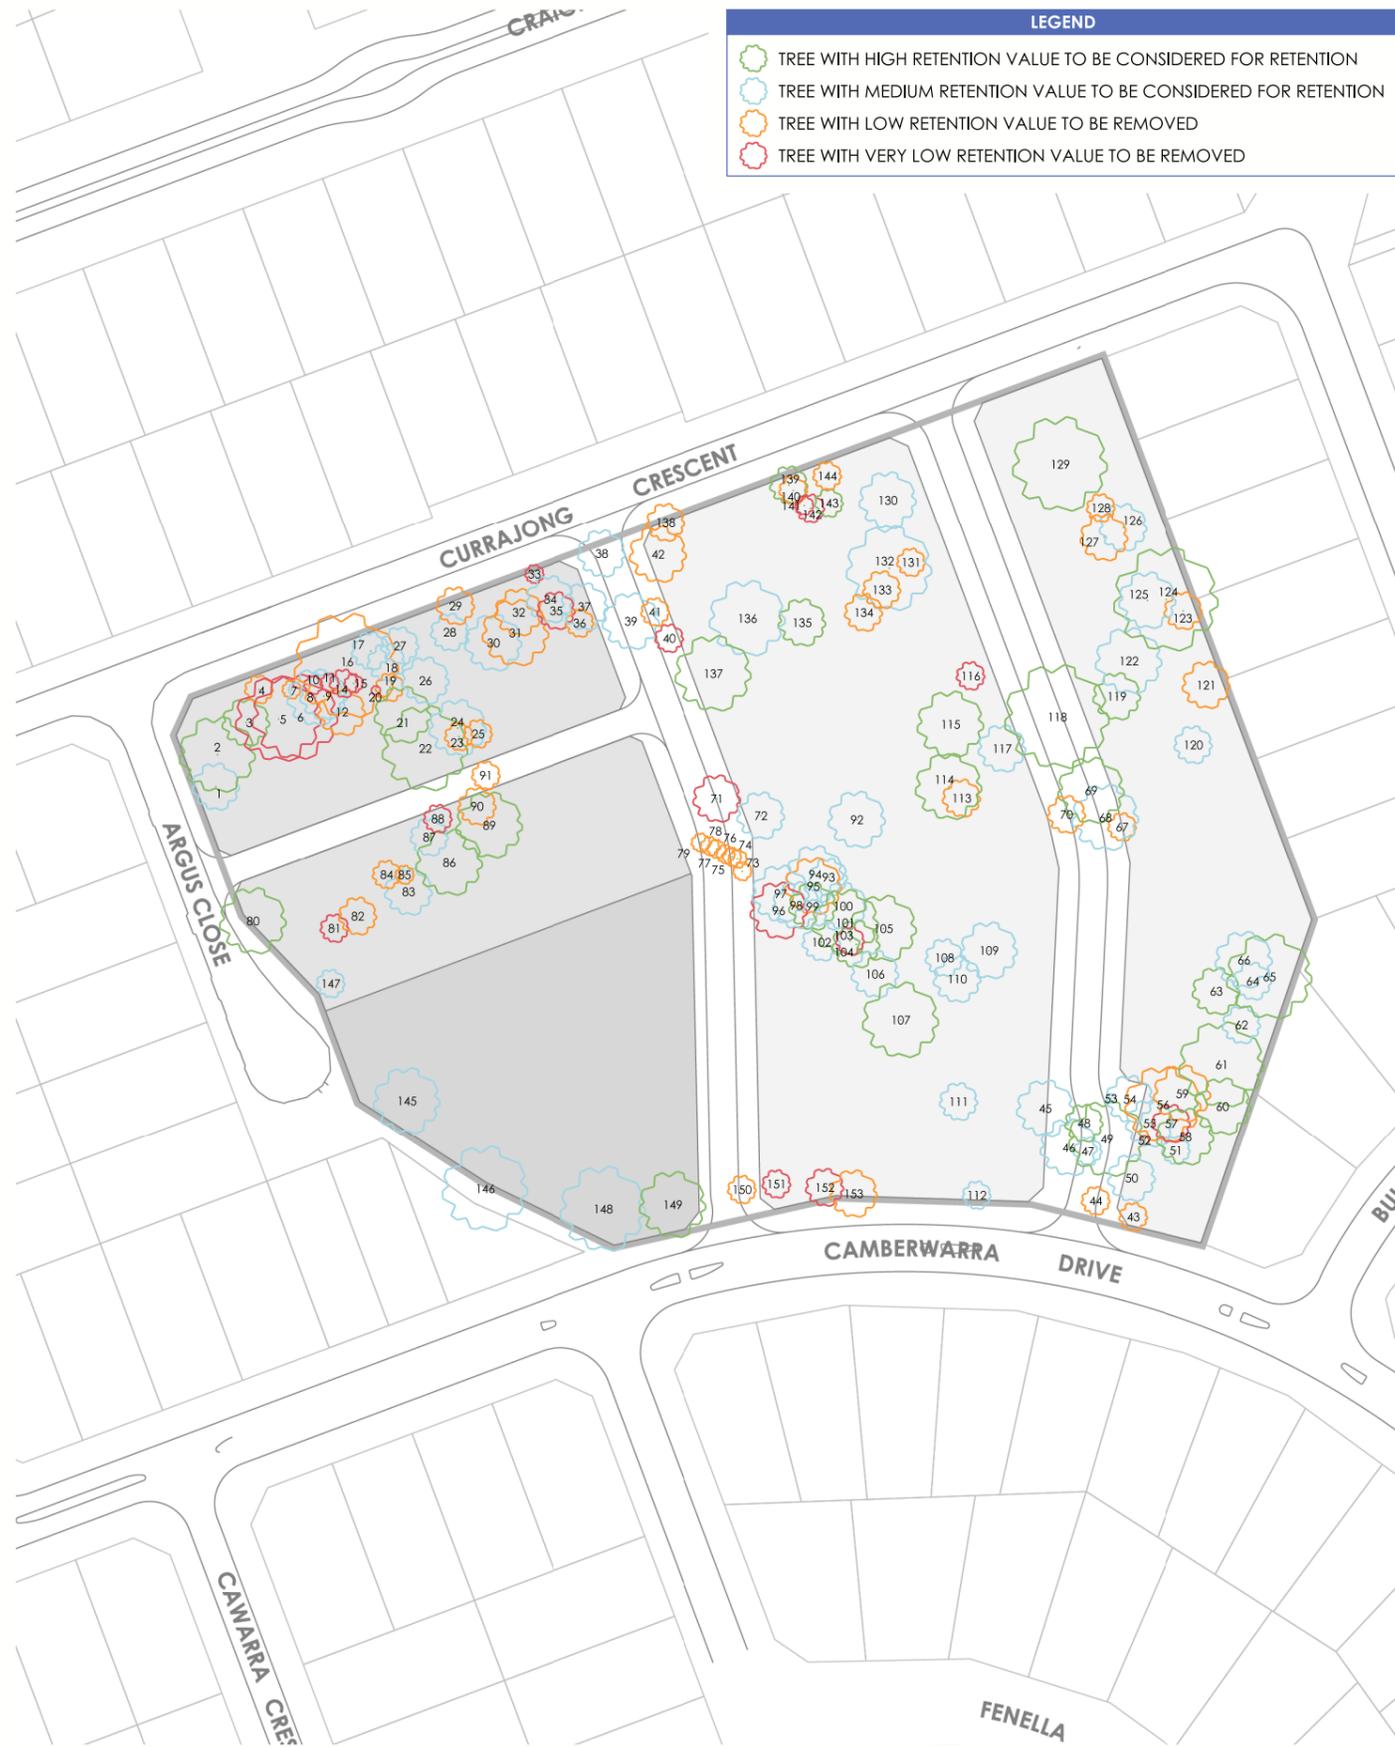
PROPOSED TREE RETENTION

- TREE WITH HIGH RETENTION VALUE TO BE CONSIDERED FOR RETENTION
- TREE WITH MEDIUM RETENTION VALUE TO BE CONSIDERED FOR RETENTION
- TREE WITH LOW RETENTION VALUE TO BE REMOVED
- TREE WITH VERY LOW RETENTION VALUE TO BE REMOVED

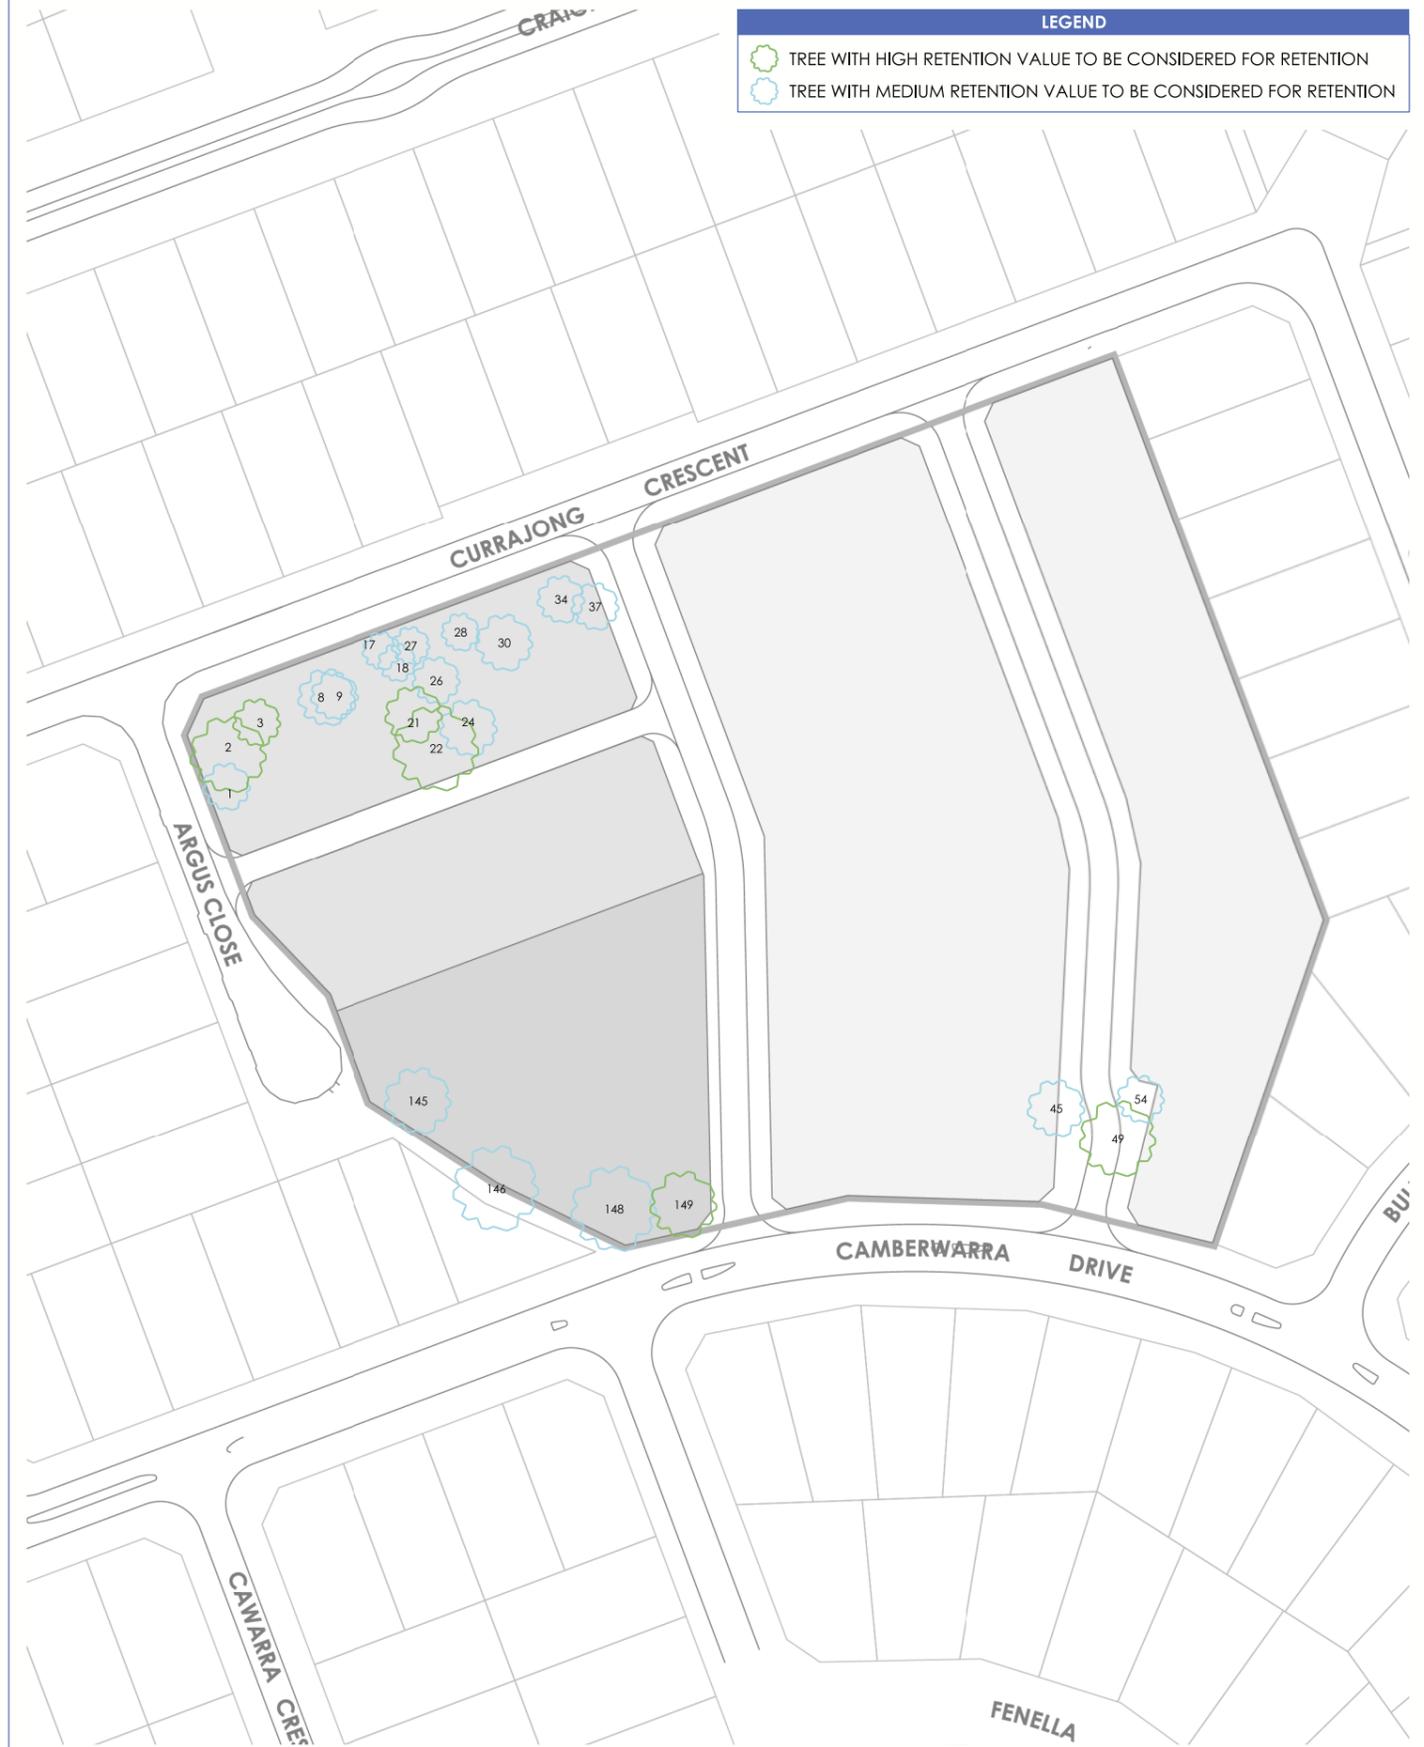
TREE RETENTION PLAN

- TREE WITH HIGH RETENTION VALUE TO BE CONSIDERED FOR RETENTION
- TREE WITH MEDIUM RETENTION VALUE TO BE CONSIDERED FOR RETENTION

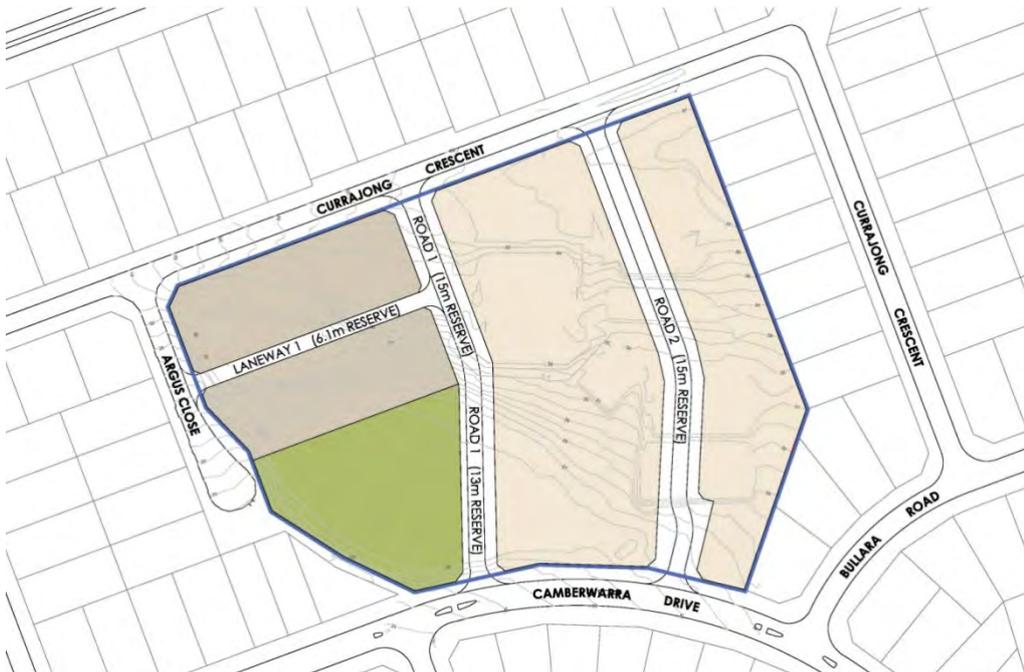
Figure 13: Proposed Movement Network

The proposed road network is shown in **Figure 13** and further discussed within **Appendix 4**. As the proposed roads are yet to be named, the identifying names as per Road 1 and Road 2 have been adopted for use in this assessment. The two internal roads of the subdivision simply connect in a north-south orientation between Camberwarra Drive and Currajong Crescent. The nature of the road layout is such that minimal external traffic is likely to use the newly created roads with the exception being local traffic whose origin/destination is Currajong Crescent itself.

The road reserve widths of Road 1 and Road 2 are typically 15m. This width is consistent with the range of 14.2m to 24m suggested in *Liveable Neighbourhoods* (WAPC 2009) as indicative reserve widths for access streets (those that accommodate shared pedestrian, bike and vehicle movements). The lower reserve width is generally for short, low volume, and low parking demand streets. The higher reserve width allows for a median and/or additional road features such as parking and paths to be incorporated. It is noted that the reserve width is reduced locally immediately adjacent to the public open space being 13m, with a 2.5m verge along the public open space. This is achievable through the reduced verge width allowance in *Liveable Neighbourhoods* for only 1m adjacent to parks.

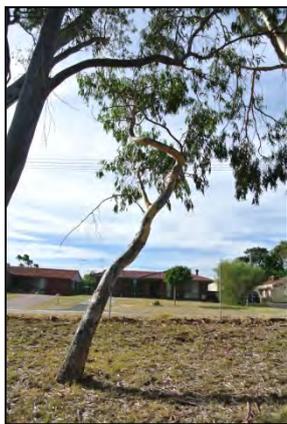
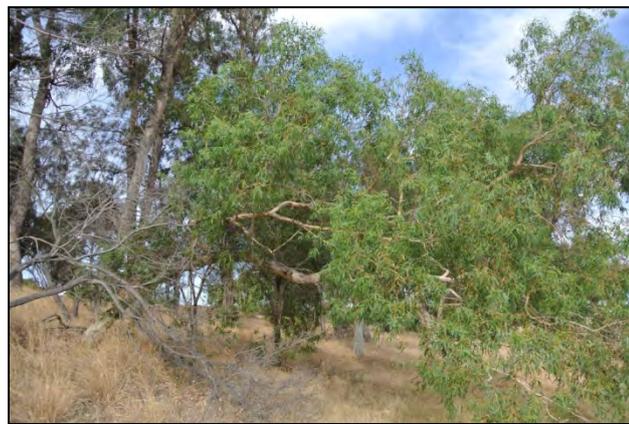
A number of the trees on this Site also showed to have grown on lean (in some instances severely so) as a result of their proximity to each other and influence of adjacent trees (limiting availability of physical space and light); examples of which can be seen in the images below.

In many instances specimens of this nature will develop amounts of reactive woody tissues to enable them to maintain support of their above ground parts, and as such the risks associated with such trees is not necessarily greater than if they had grown on a more vertical plane.

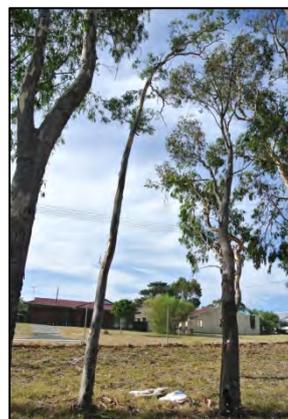
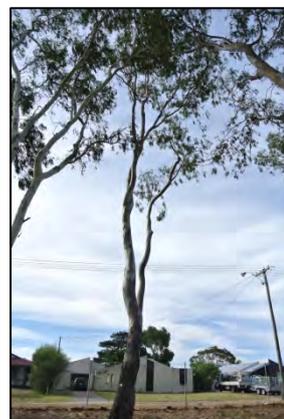
A number of the trees also showed to have developed (what can be best described as) a somewhat 'leggy' upright canopy habit with relatively little lower canopy mass; again due to their proximity to each other and availability of physical space and light; examples seen in the images below.

Whilst this is again not necessarily always a cause of major concern, trees with structures of this nature can have an increased potential for failure; particularly if they become suddenly exposed to wind forces that they are currently protected from as a result of the clearing of other adjacent trees.

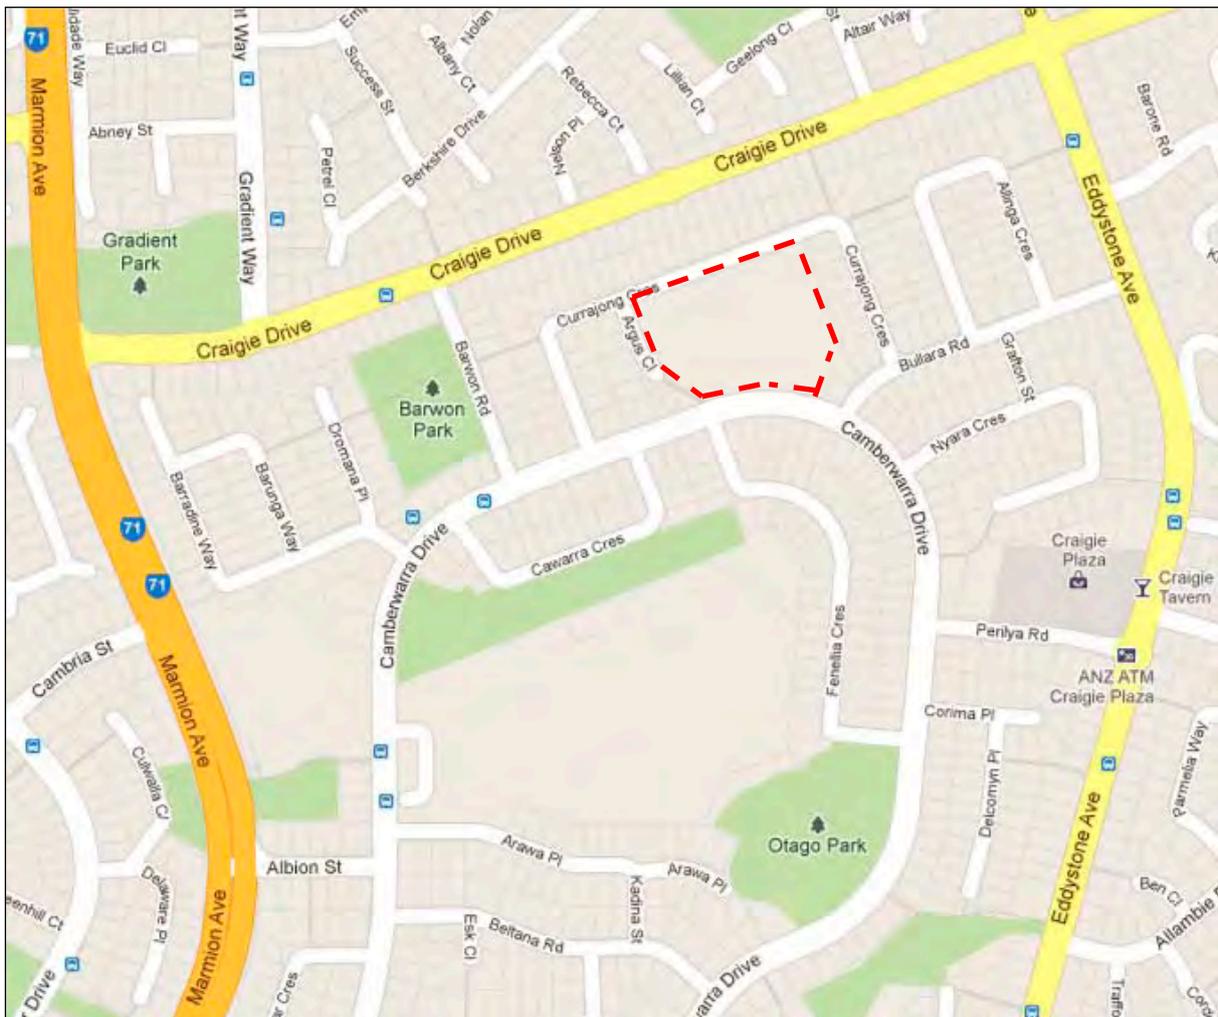
Figure 3.1: Existing Road Network

Figure 3.1 illustrates the road network servicing the subject site. Three existing roads directly abut the site, being Camberwarra Drive, Currajong Crescent and Argus Close.

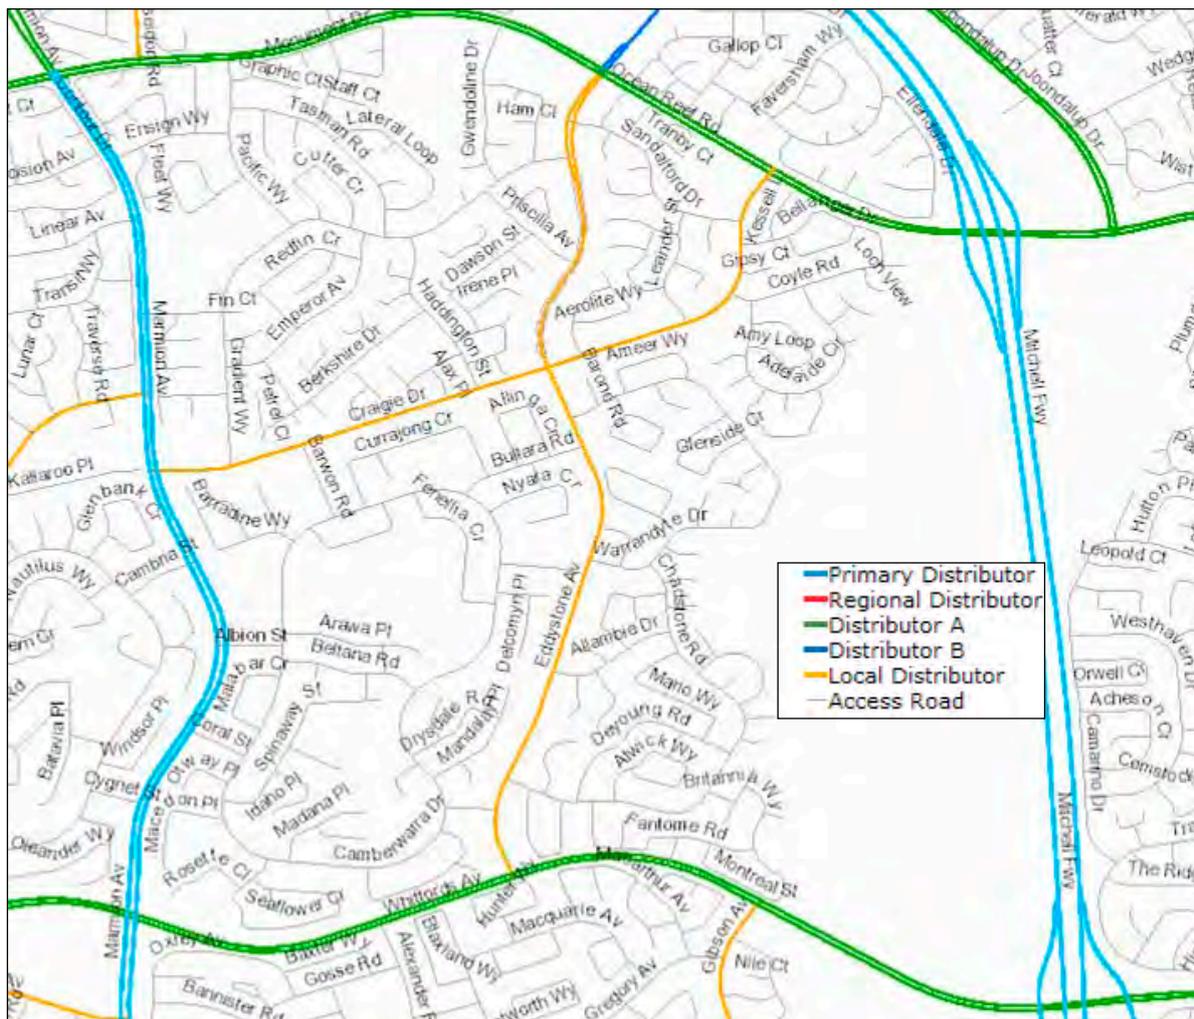
Figure 3.2: Road Hierarchy of Surrounding Road Network

Figure 3.2 outlines the road hierarchy classification of the surrounding road network.

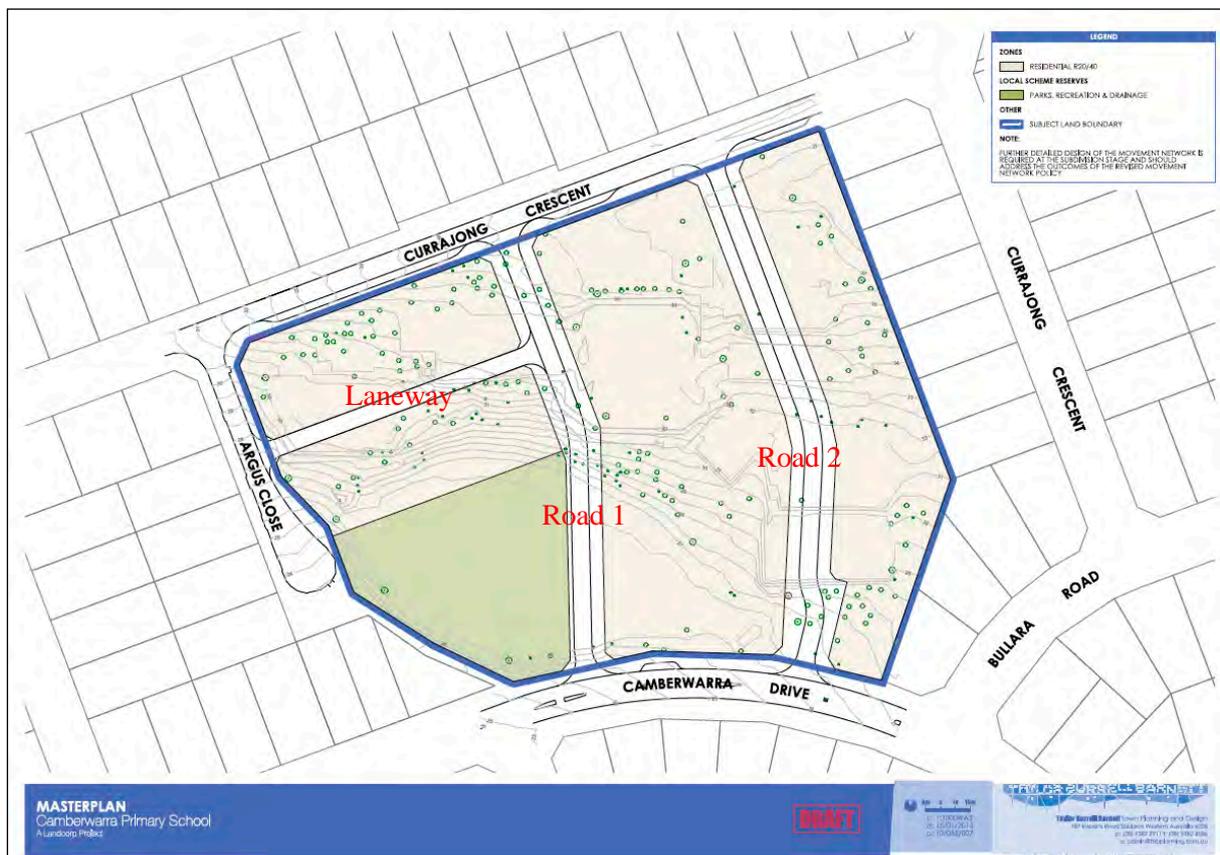
Figure 4.1: Internal Road Network and Identifying Names

The proposed road network is shown in **Figure 4.1**. As the proposed roads are yet to be named, the identifying names as per **Figure 4.1** have been adopted for use in this assessment. The two internal roads of the subdivision simply connect in a north-south orientation between Camberwarra Drive and Currajong Crescent. The nature of the road layout is such that minimal external traffic is likely to use the newly created roads with the exception being local traffic whose origin/destination is Currajong Crescent itself.

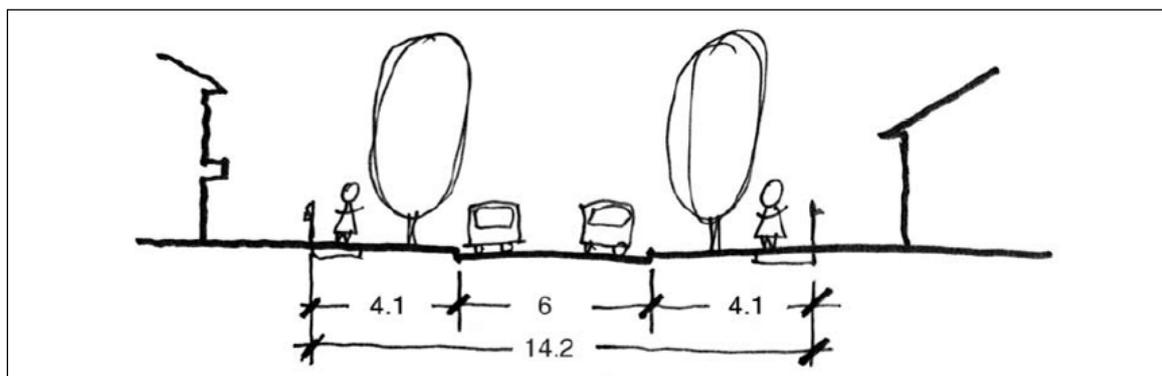
Figure 4.2: Sample Road Cross Section Narrow Yield Access Street, 40km.hr, <1000vpd

All roads within the structure plan are likely to carry less than 1,000 vehicles per day hence would be defined as access roads. It would therefore be considered appropriate to adopt a narrow yield access street cross section with typically a 6m wide pavement. **Figure 4.2** shows a sample cross section of an access road as outlined in *Liveable Neighbourhoods* (WAPC 2009) that would be suitable for a road reservation width of 14.2m similar to the roads within the Structure Plan.

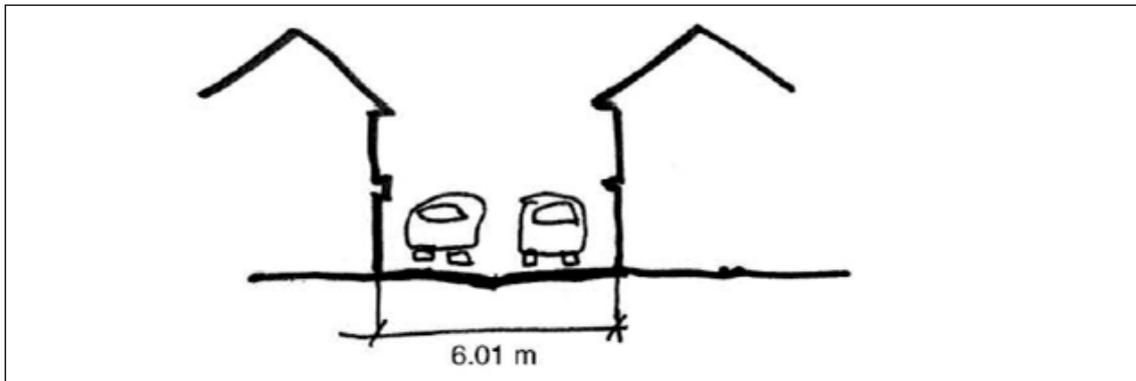
Figure 4.3: Sample Road Cross Section Laneway Rear Access

Figure 4.3 shows a sample cross section for a rear laneway.

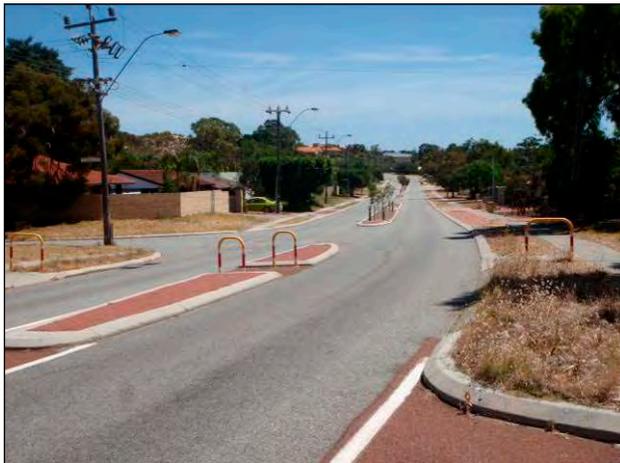
Photo 9: Approximate sight lines from Road 1 along Camberwarra Dr to the west

Potential sight lines from the proposed intersection connections were observed on site as shown in **Photos 9 to 12**. The sight lines are good and are appropriate within the residential environment.

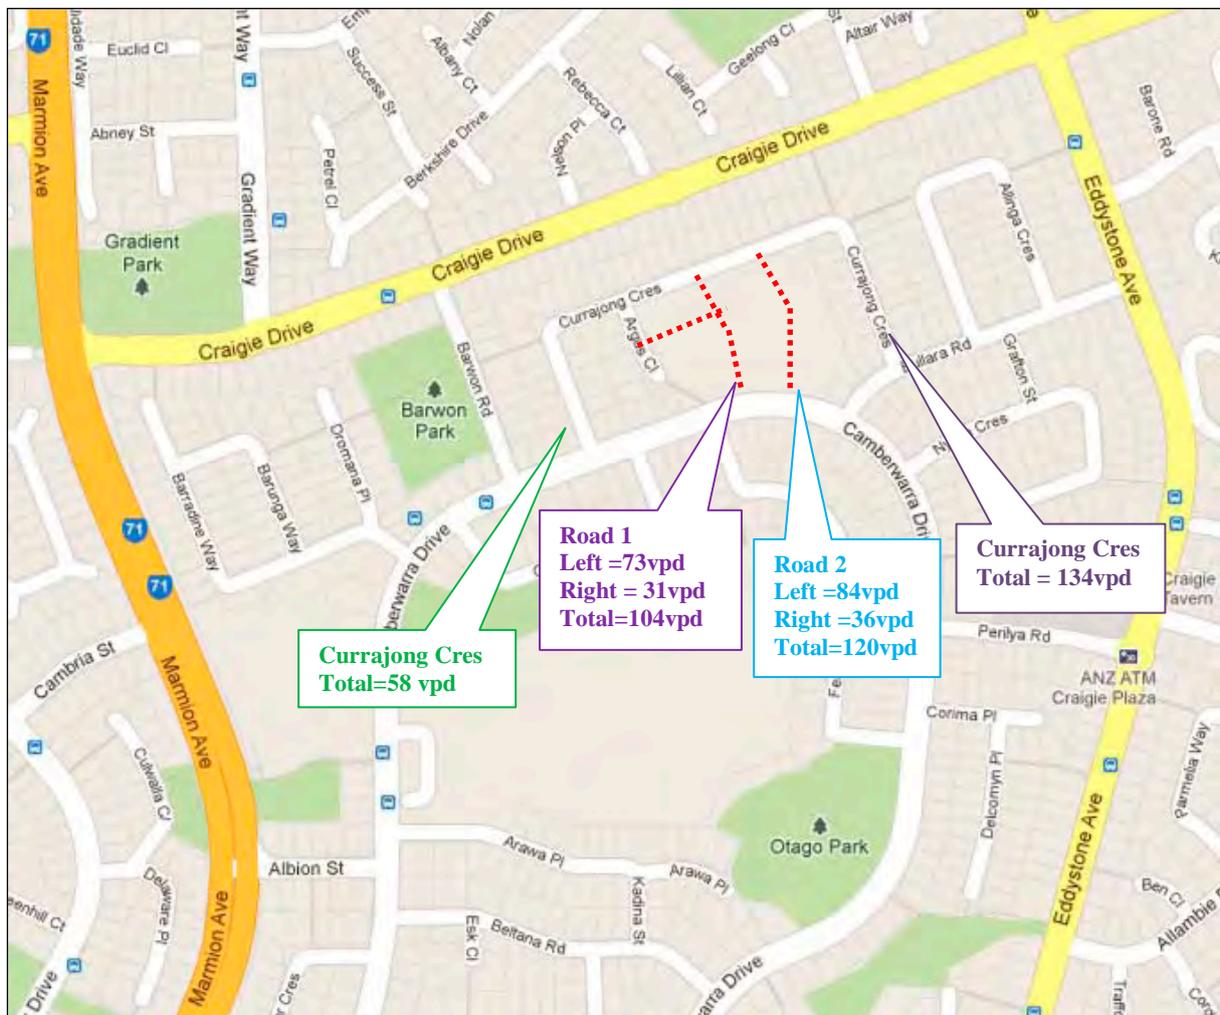
Figure 5.1: Additional Daily Traffic Volume

- 30% in a westerly direction along Camberwarra Dr
- 70% is a easterly direction along Camberwarra Dr or Bullara Road

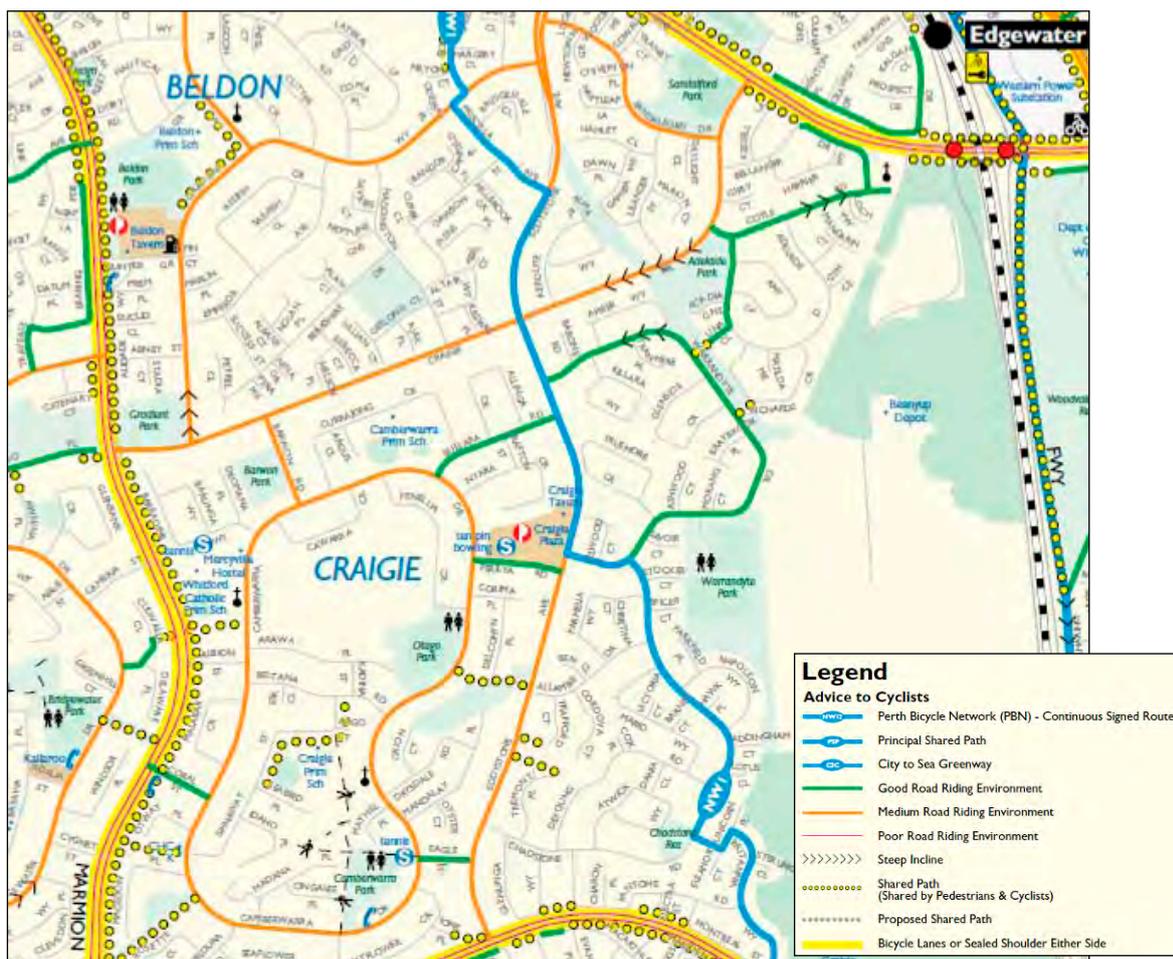
Figure 7.1: Existing Cycling Facilities in the vicinity of the Site

Figure 7.1 shows the existing cycling facilities in the vicinity of the site.

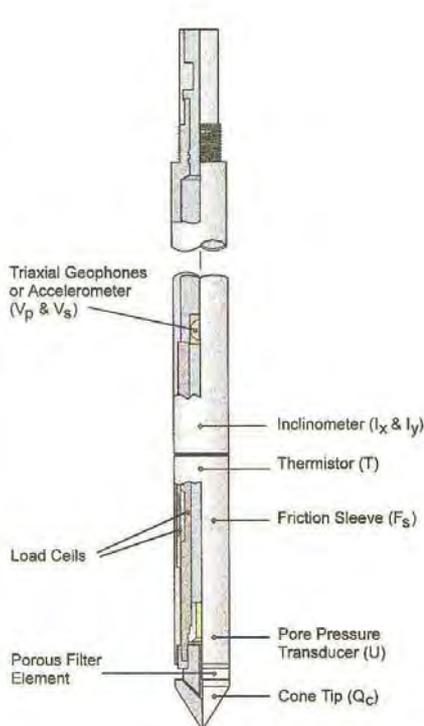
Figure 1: Cone Diagram

- Cone tip resistance q_c
- Sleeve friction f_s
- Inclination (from vertical) i
- Depth below ground z

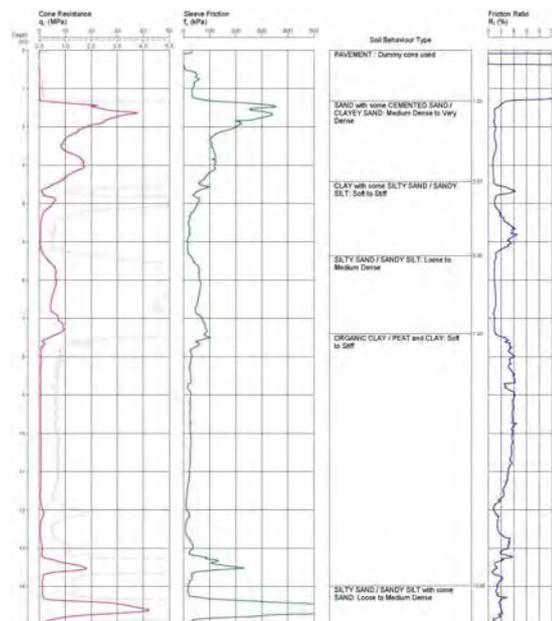
Figure 4: Sample Cone Plot

Other applications of CPT include ground improvement monitoring (testing before and after works), salinity and contaminant plume mapping (conductivity cone), preloading studies and verification of strength gain.

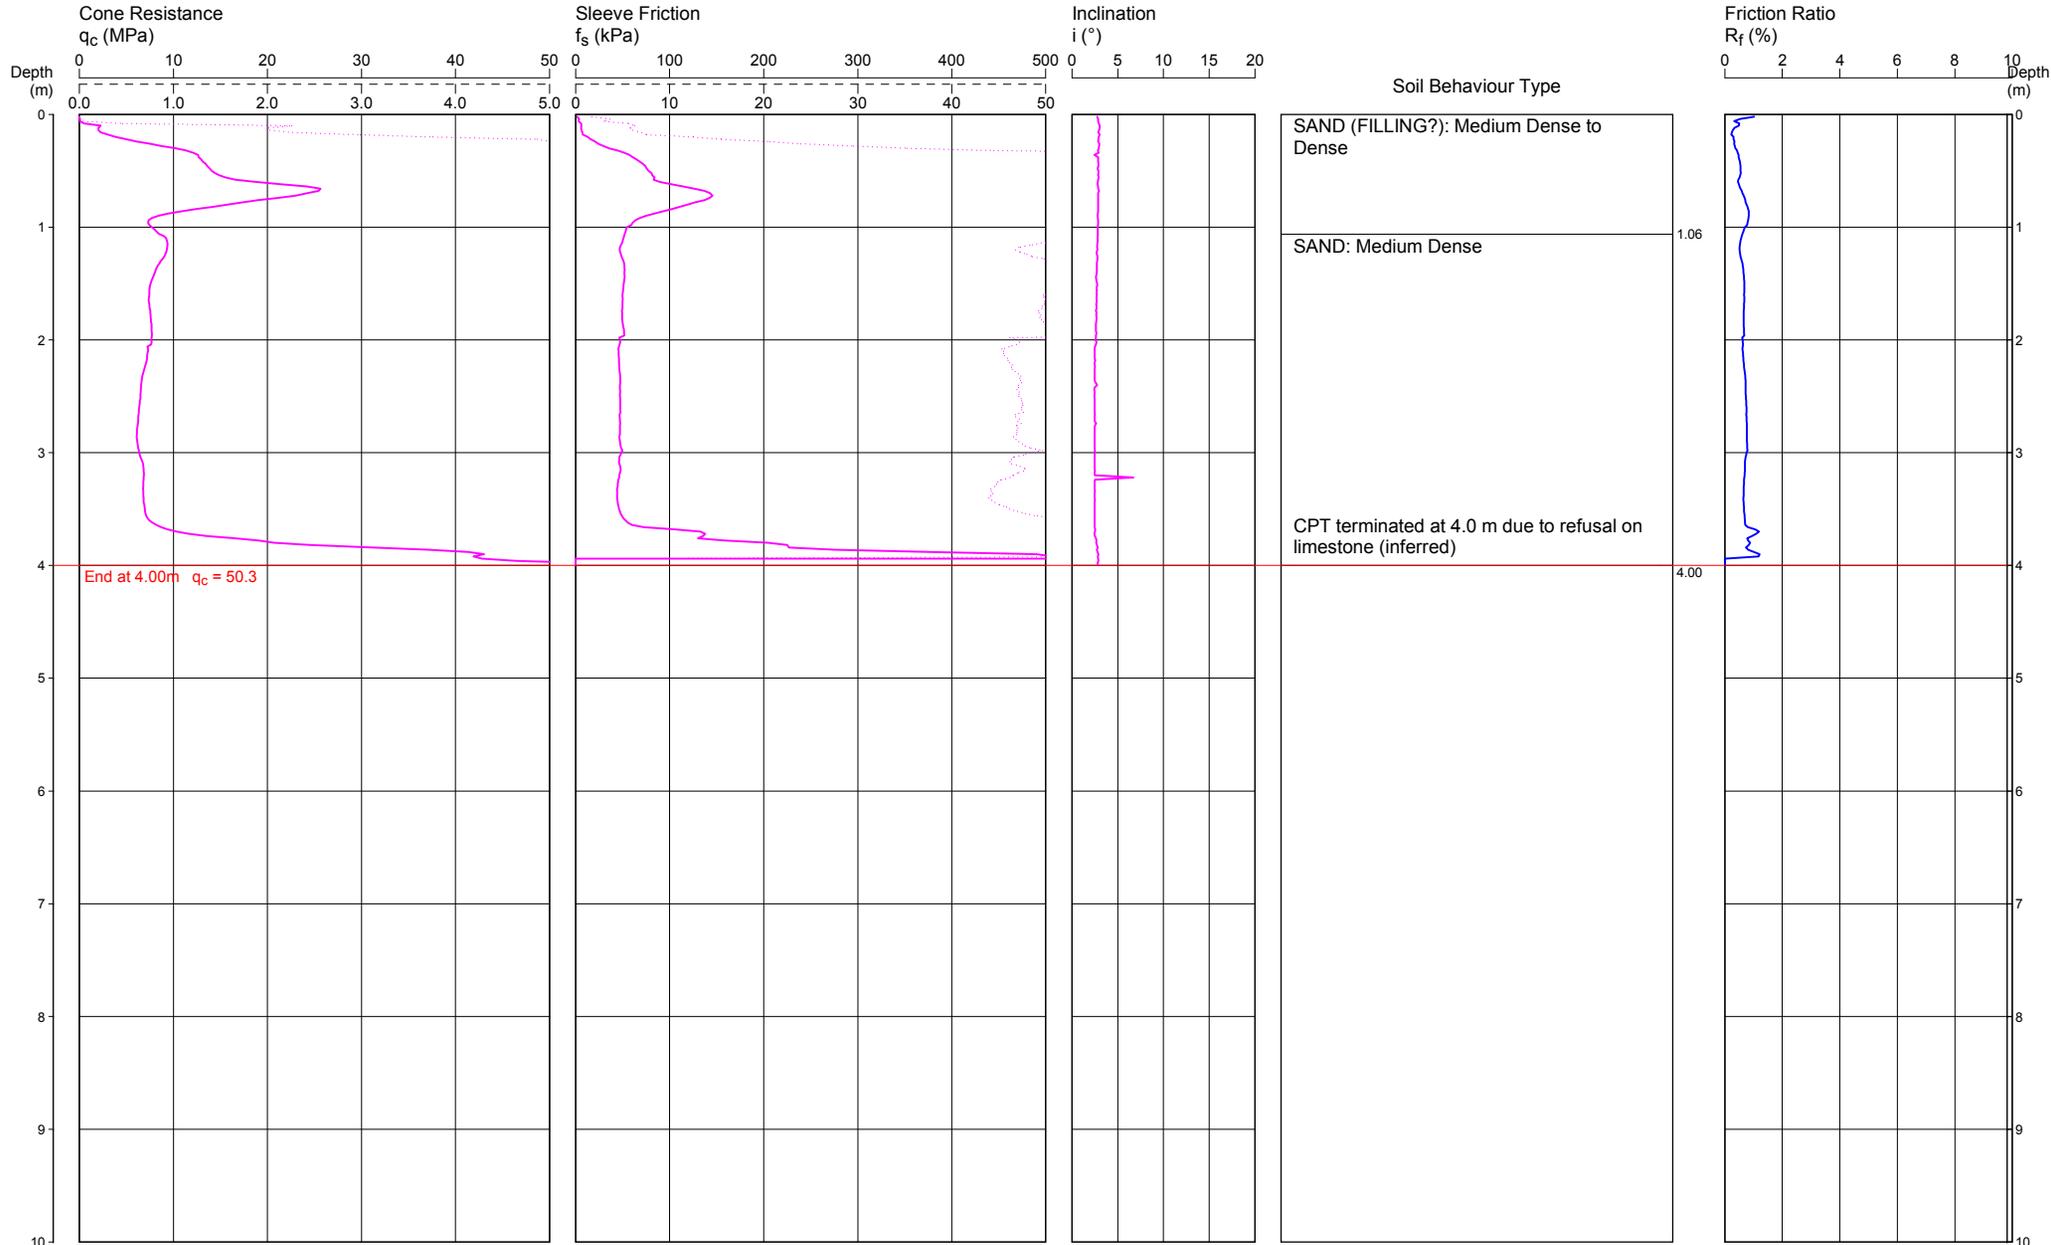
REMARKS: * Surface level interpolated from survey plan provided by the client. File: P:\82006 Craigie, Camberwarra Primary School Site\Field\CPT1.CP5

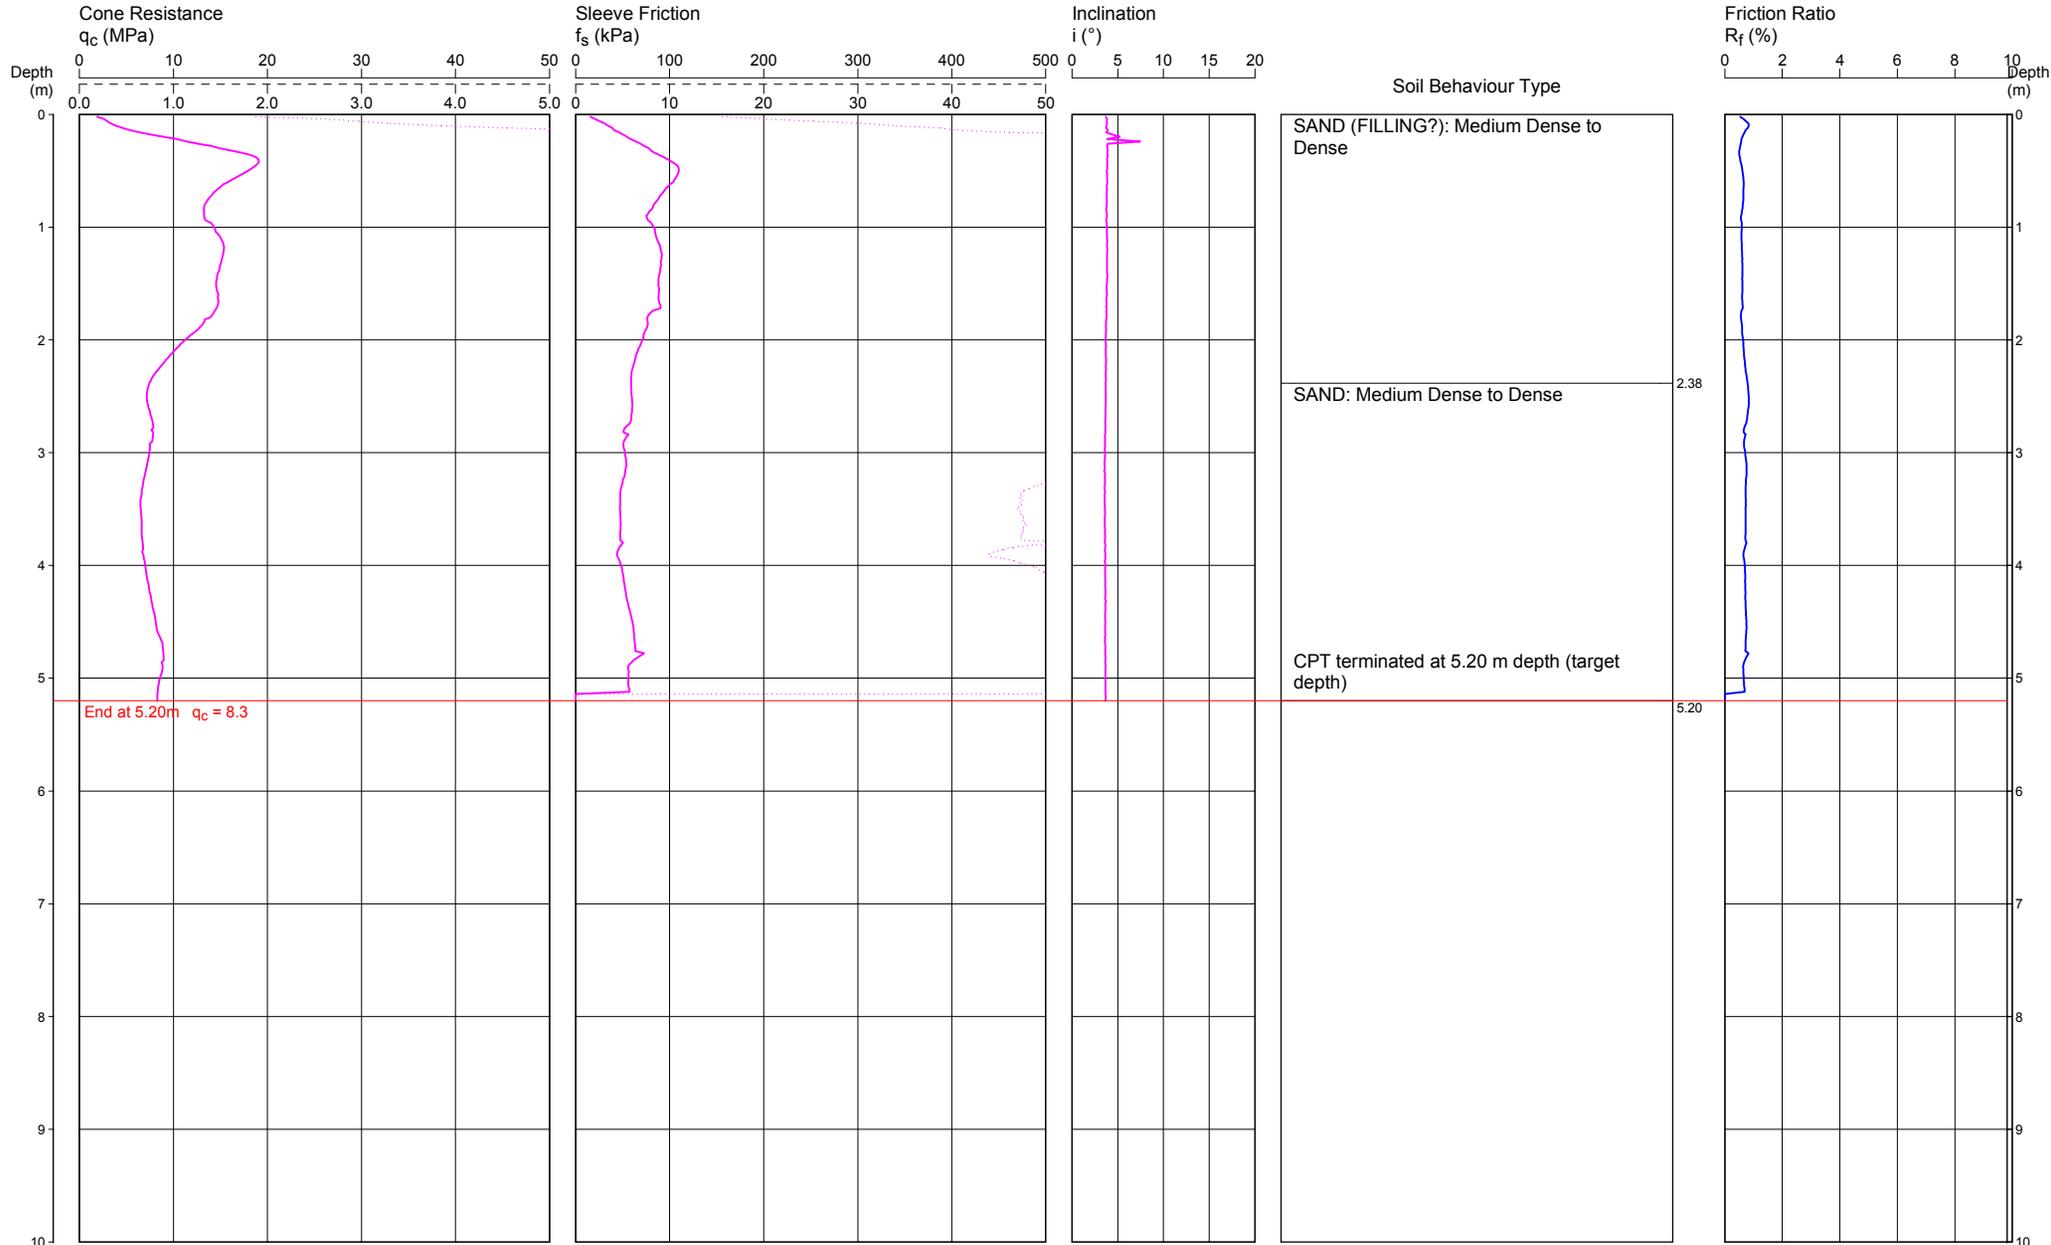
REMARKS: * Surface level interpolated from survey plan provided by the client. File: P:\82006 Craigie, Camberwarra Primary School Site\Field\CPT2.CP5
Cone ID: Probedrill Type: EC04
