Camberwarra ~~Primary School Site~~ Local Structure Plan

'Track Changes' Draft for consideration by the City of Joondalup Council
December 2013

STRUCTURE PLAN N^o. ~~(TBC)~~16

This Structure Plan is prepared under the provisions of Part 9 of the City of Joondalup *District Planning Scheme No. 2*.

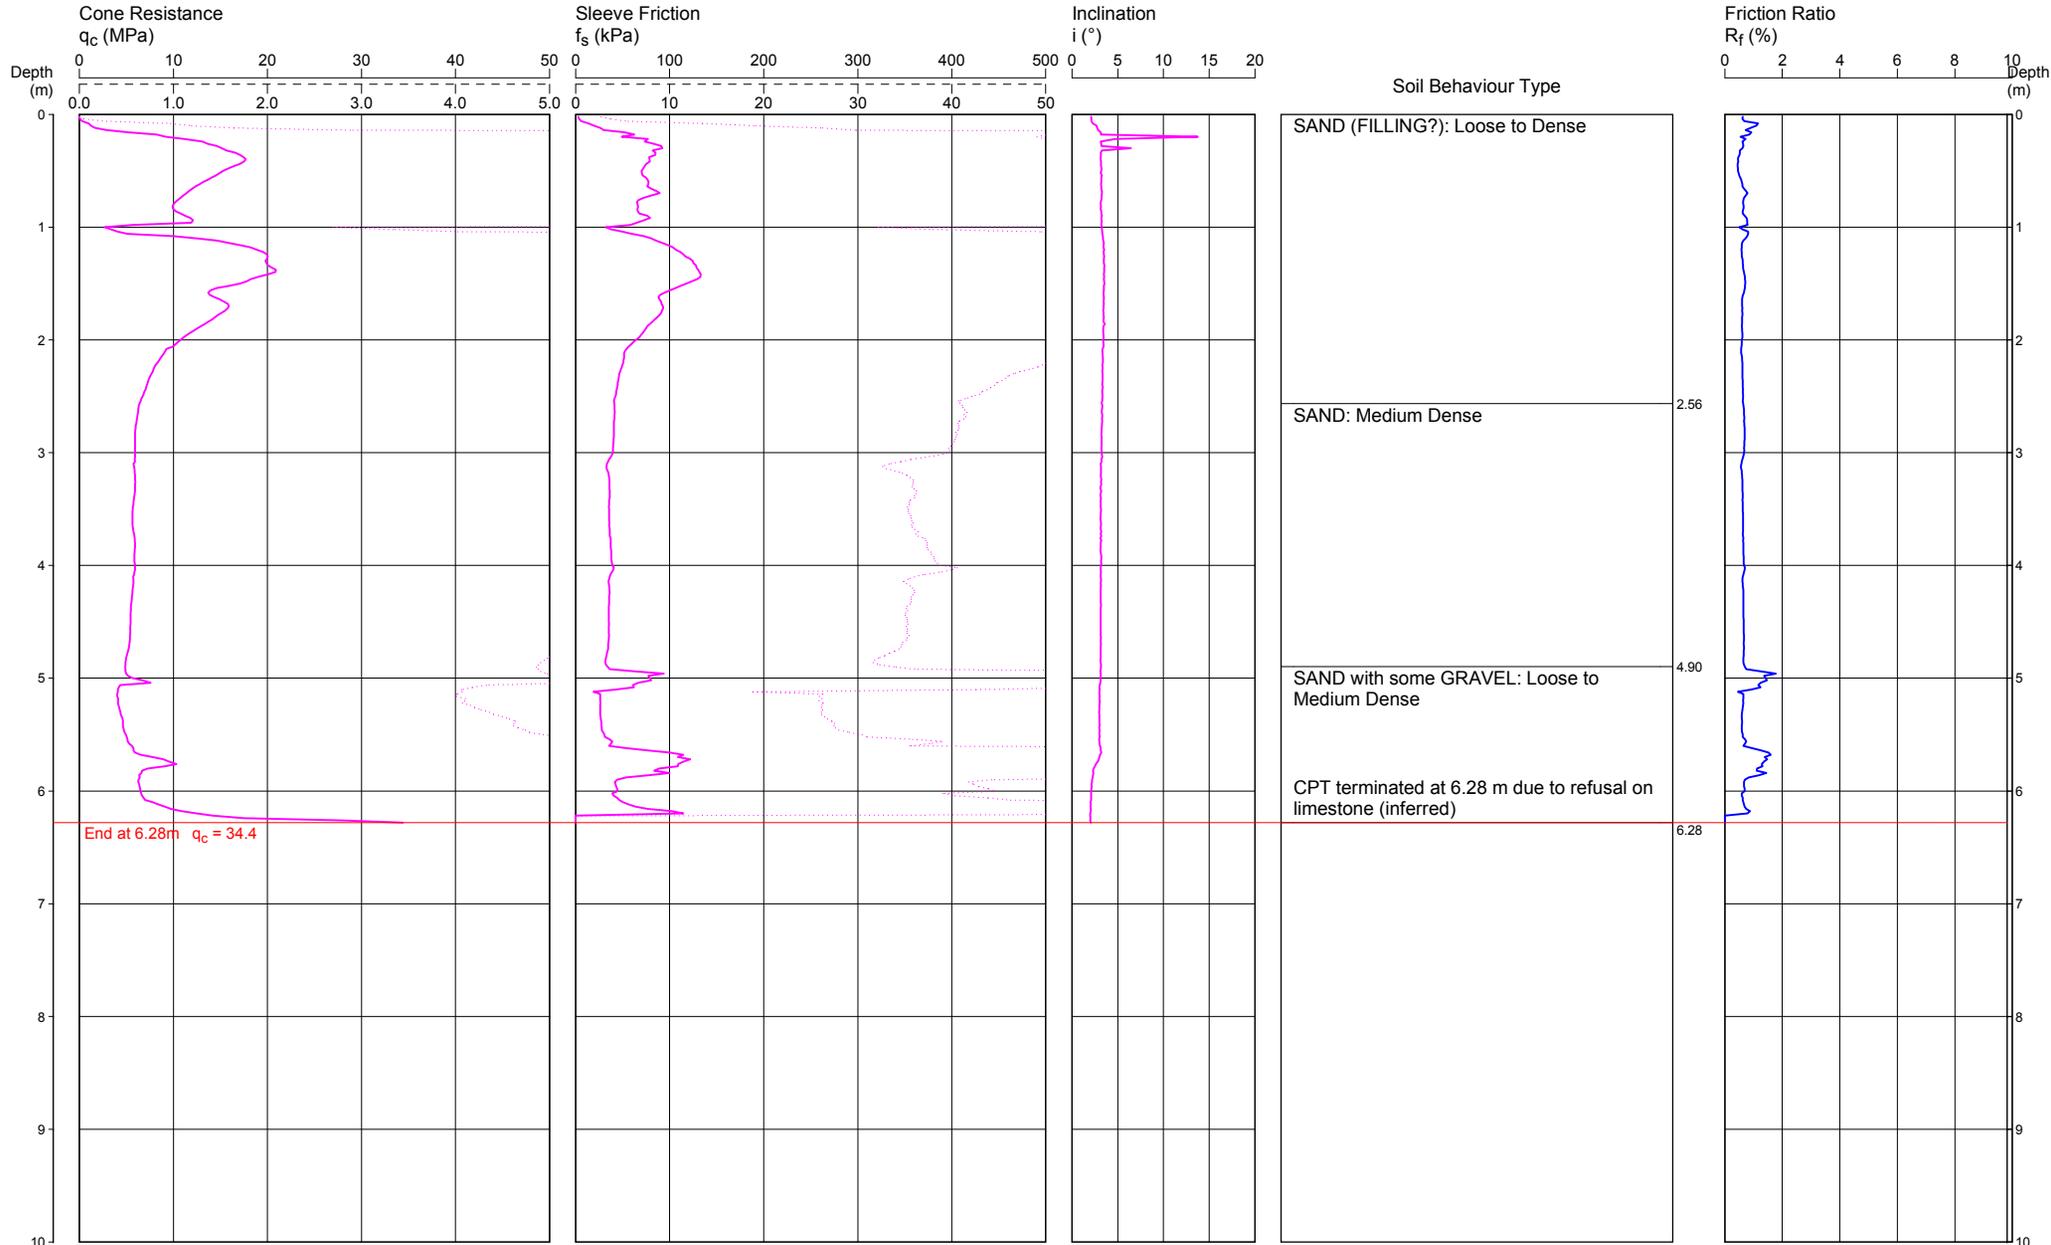
REMARKS: * Surface level interpolated from survey plan provided by the client. File: P:\82006 Craigie, Camberwarra Primary School Site\Field\CPT3.CP5
Cone ID: Probedrill Type: EC04
